Issue Preventing Exaquantum Installation

KB-1081-22

Document Summary	
Article Type	User Guide
Products Affected	Exaquantum/PIMS
Versions Affected	R3.01 or later
Function Affected	Exaquantum Installation
Available Resolution	DCOM Reconfiguration
Audience	Administrators, System Integrators
Summary	Installation of Exaquantum prerequisites continue in perpetuity This document describes how to break the cycle and complete the installation
Review Date	Document to be reviewed before November 2024

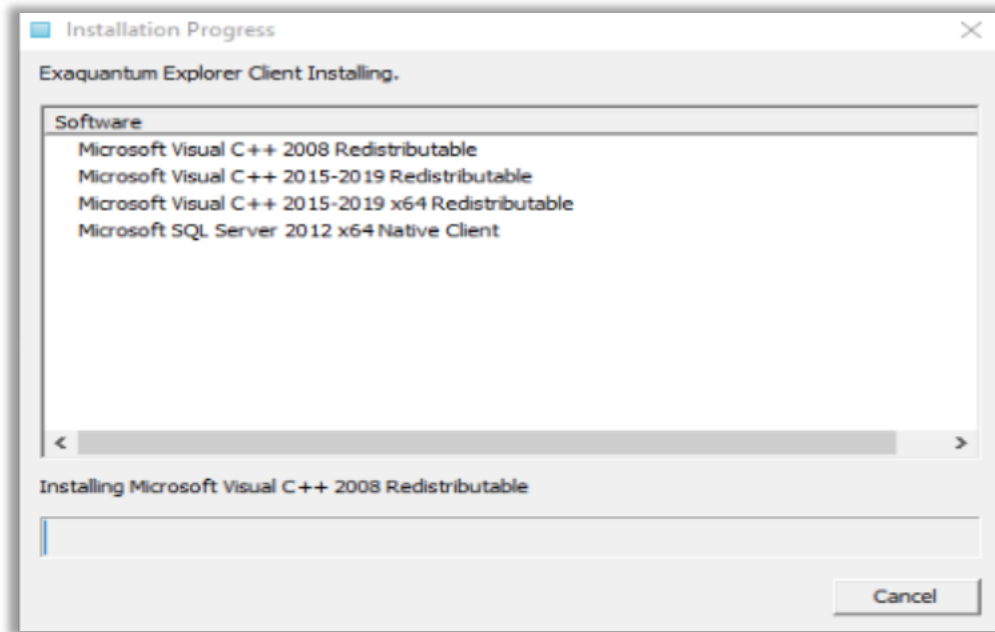
Installation of Exaquantum client does not progress beyond the prerequisites with the installation and subsequent reboot continuing in perpetuity failing to pass this point:

This is because there is a conflict between the DCOM installation requirements of the component and the computer's current DCOM settings.
